# APPLICATION NOTE

App. Note Code: 2Q-X  
Written by John Downing

## *Effects of Fouling on the Lens of OBS® Sensors*

# **Effects of Fouling on the Lens of OBS<sup>®</sup> Sensors**

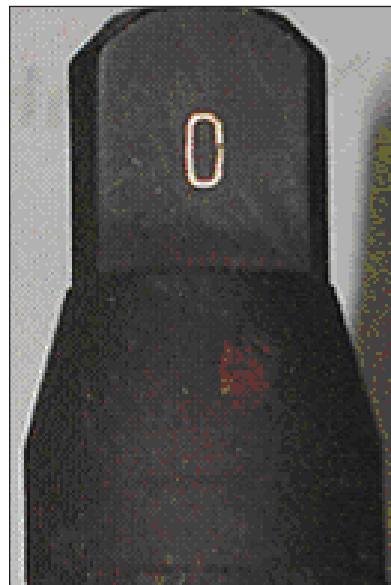
An example of a chemical film is shown in Figure 1. This chemical film produced the apparent decline in background turbidity shown in Figure 2. The film was a tannin-based compound common in streams and swamps.

*Figure 1. An OBS sensor fouled with a tannin-based film.*

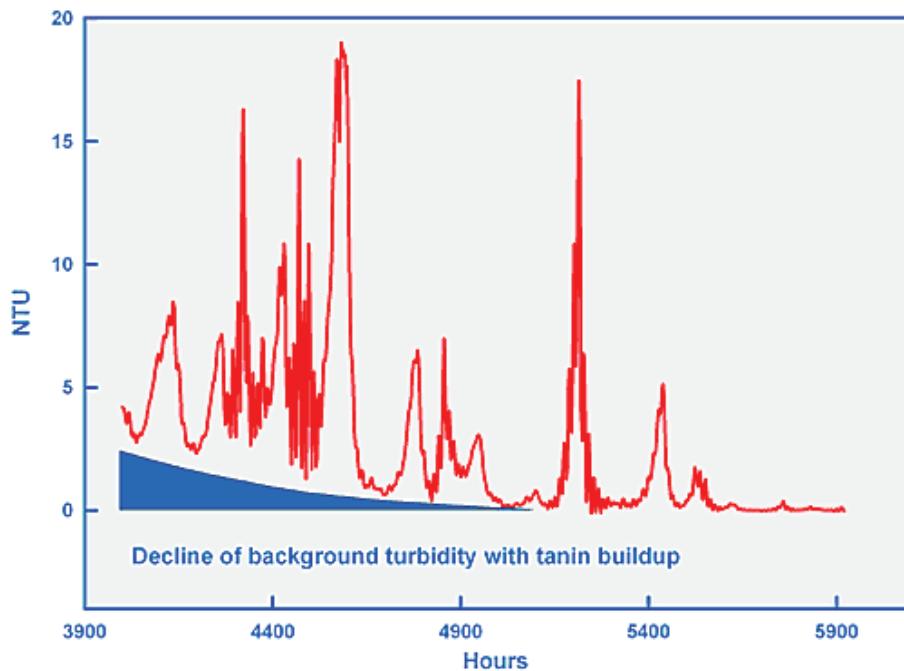
*Figure 2. This graph shows the affect that a tannin-based film had on the OBS measurements*

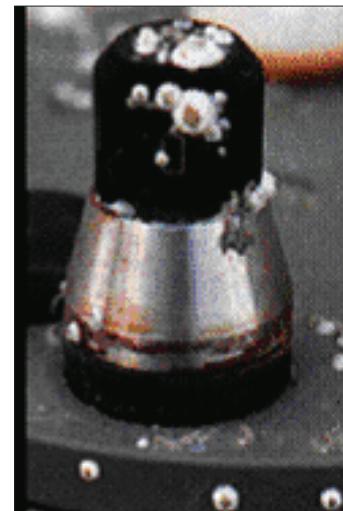
Barnacle growth on moored OBS sensors is very common in a shallow marine environment. Figure 3 shows barnacle growth over the infrared-emitting diode (IRED) and photodetectors of an OBS sensor moored off the California coast. The barnacles obscured the light emitter and produced declining turbidity.

Figure 3. The barnacles on this OBS sensor produced erroneously low turbidity readings.

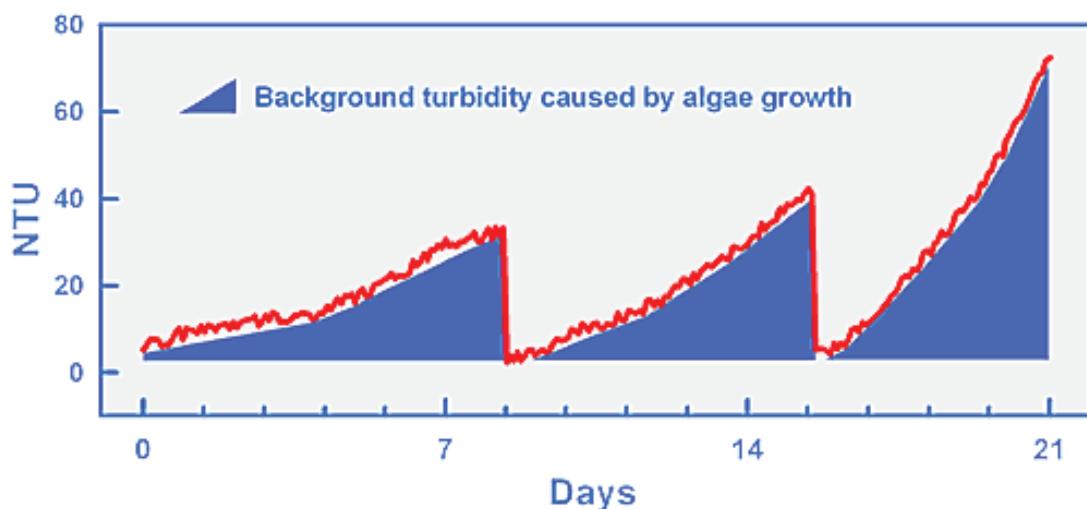
Fouling does not always result in an apparent decline in turbidity. For example, rapid algal growth on an OBS sensor in Tampa Bay caused turbidity to increase (see Figure 4). This occurred because algae grew into the sample volume and reflected light into the photodetectors, which created a turbidity-like signal. The resulting effects were both severe and rapid in onset (~1 week).

Figure 4. An OBS sensor deployed in Tampa Bay was fouled with algae. As this graph shows, the algae reflected light into the photodetectors resulting in a turbidity-like signal.
