App. Note Code: 2Q-X
Written by John Downing

Effects of Fouling on the Lens of OBS[®] Sensors

Copyright (C) April 2008 Campbell Scientific, Inc.

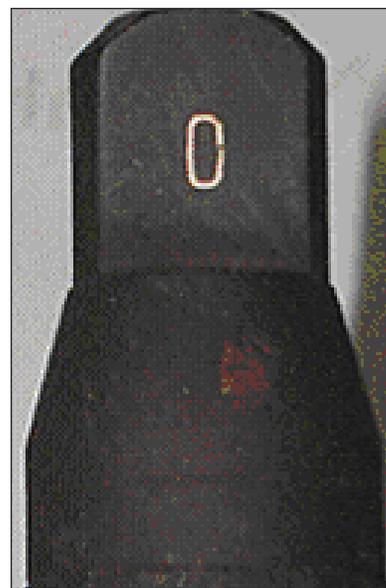
Figure 1. An OBS sensor fouled with a tannin-based film.

An example of a chemical film is shown in Figure 1. This chemical film produced the apparent decline in background turbidity shown in Figure 2. The film was a tannin-based compound common in streams and swamps.

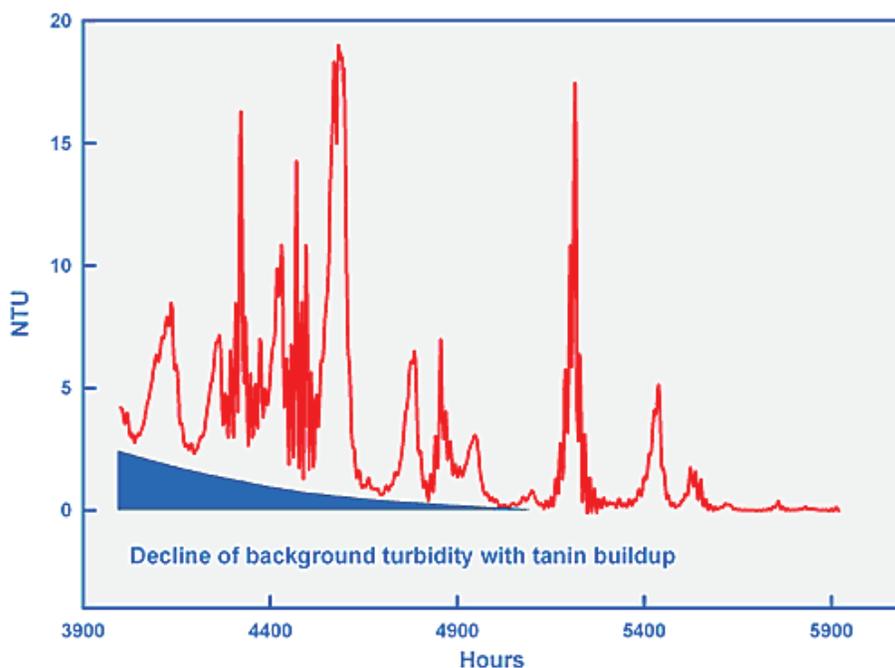
Figure 2. This graph shows the affect that a tannin-based film had on the OBS measurements

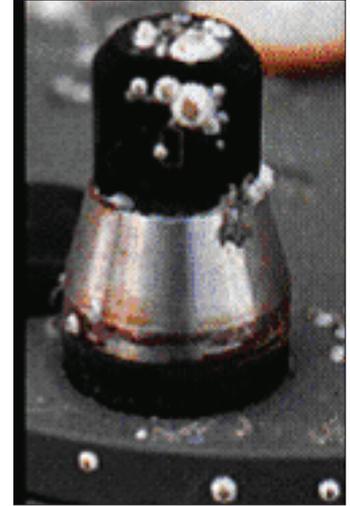
Barnacle growth on moored OBS sensors is very common in a shallow marine environment. Figure 3 shows barnacle growth over the infrared-emitting diode (IRED) and photodetectors of an OBS sensor moored off the California coast. The barnacles obscured the light emitter and produced declining turbidity.

Figure 3. The barnacles on this OBS sensor produced erroneously low turbidity readings.

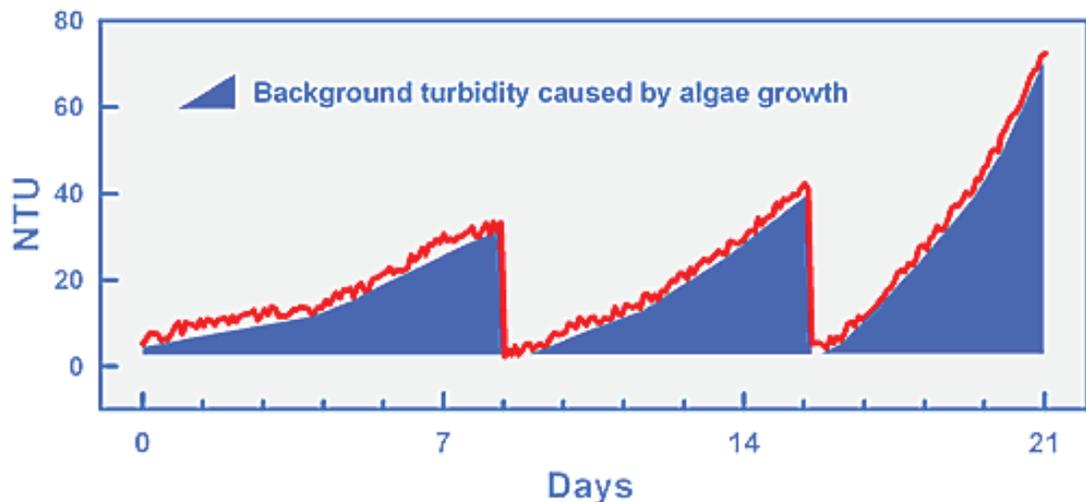
Fouling does not always result in an apparent decline in turbidity. For example, rapid algal growth on an OBS sensor in Tampa Bay caused turbidity to increase (see Figure 4). This occurred because algae grew into the sample volume and reflected light into the photodetectors, which created a turbidity-like signal. The resulting effects were both severe and rapid in onset (~1 week).

Figure 4. An OBS sensor deployed in Tampa Bay was fouled with algae. As this graph shows, the algae reflected light into the photodetectors resulting in a turbidity-like signal.
