# APPLICATION NOTE

## **GPS16X-HVS Firmware** **Update Procedure**

4/19

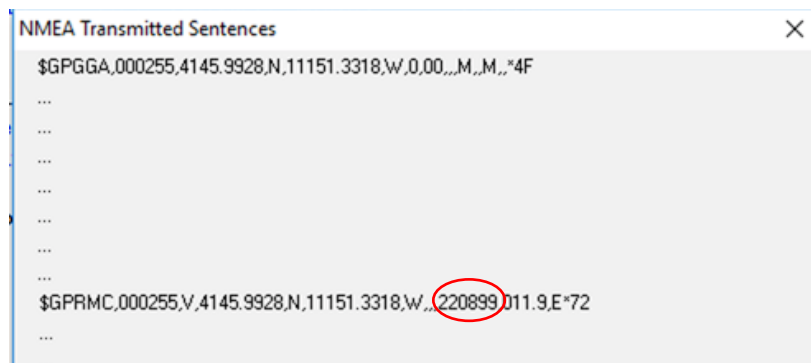
If the \$GPRMC date shows something other than the current date (following example shows 220899, which is the 22nd day of August 1999), it did not roll over, and you need to update the firmware by following the remaining steps in the procedure:

9. If you need to update the firmware, go to **Config > Update Software**.

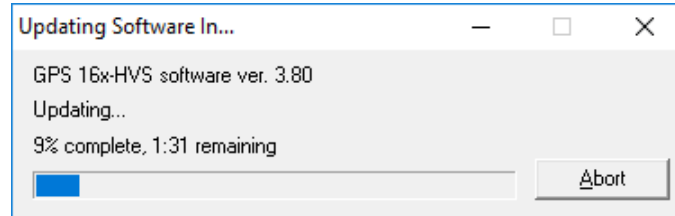
The version listed in the progress screen is the firmware version that is currently in the GPS16X-HVS and not the firmware version to which it is being updated. This progress screen shows the GPS16X-HVS had version 3.80, which will be updated to version 4.20.
