Floating station weathers an historic storm

Application type: Buoy-based meteorological and hydrological monitoring

Project area: Ross River Dam, Townsville, Australia

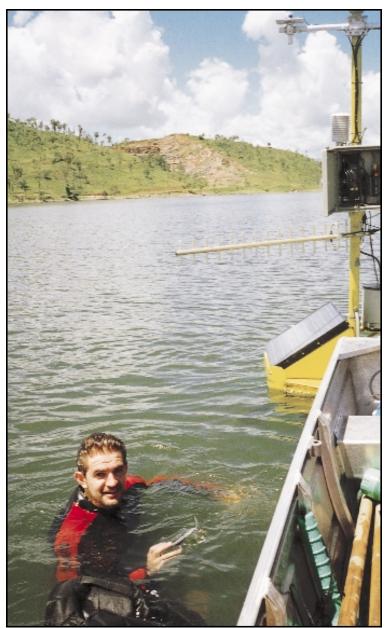
Campbell Scientific Australia's Chris Kellet installs the underwater thermistor chain on Ross River Dam's weather station.

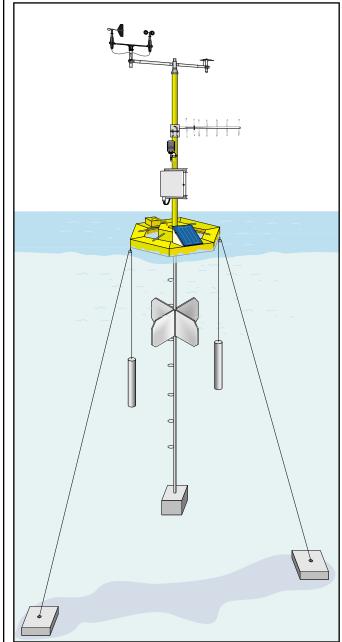
The floating weather station on Ross River Dam is anchored to the reservoir bed by a system of counterweights and pulleys, creating a fixed lateral position while still allowing buoyancy. Even in heavy waves, the mast remains vertical thanks to a gimbal block attachment to the buoy. Beneath the surface, a thermistor chain is suspended from the buoy to measure temperatures at depths to 12 meters. Above-buov instrumentation includes a Campbell Scientific CR10X datalogger which records

and stores raw data and is programmed to calculate evaporation rates as well. Data retrieval is accomplished via cellular telephone, live in real time, through a voice synthesizer, or by downloading directly to council offices. Once the data are stored, displays of three-dimensional graphs can be created using CSI's RTDM software.

Campbell Scientific Australia and the New South Wales Department of Land and Water Conservation worked together to design, supply and install a buoymounted automatic weather station capable of measuring wind speed and direction, humidity, solar radiation, rainfall and air and water temperatures. The weather station was mounted on a 3-meter mast above a buoy with thermistors mounted

on a chain trailing down to 12 meters below the surface. A voice-synthesized modem with cellphone was installed to provide both voice and computer access to the floating station. Twelve months worth of data was routinely collected before the 'main event' arrived.
