# Delaware: Urgent Action on Bridge

*Campbell gear used in emergency inspection of I-495 bridge over Christina River*

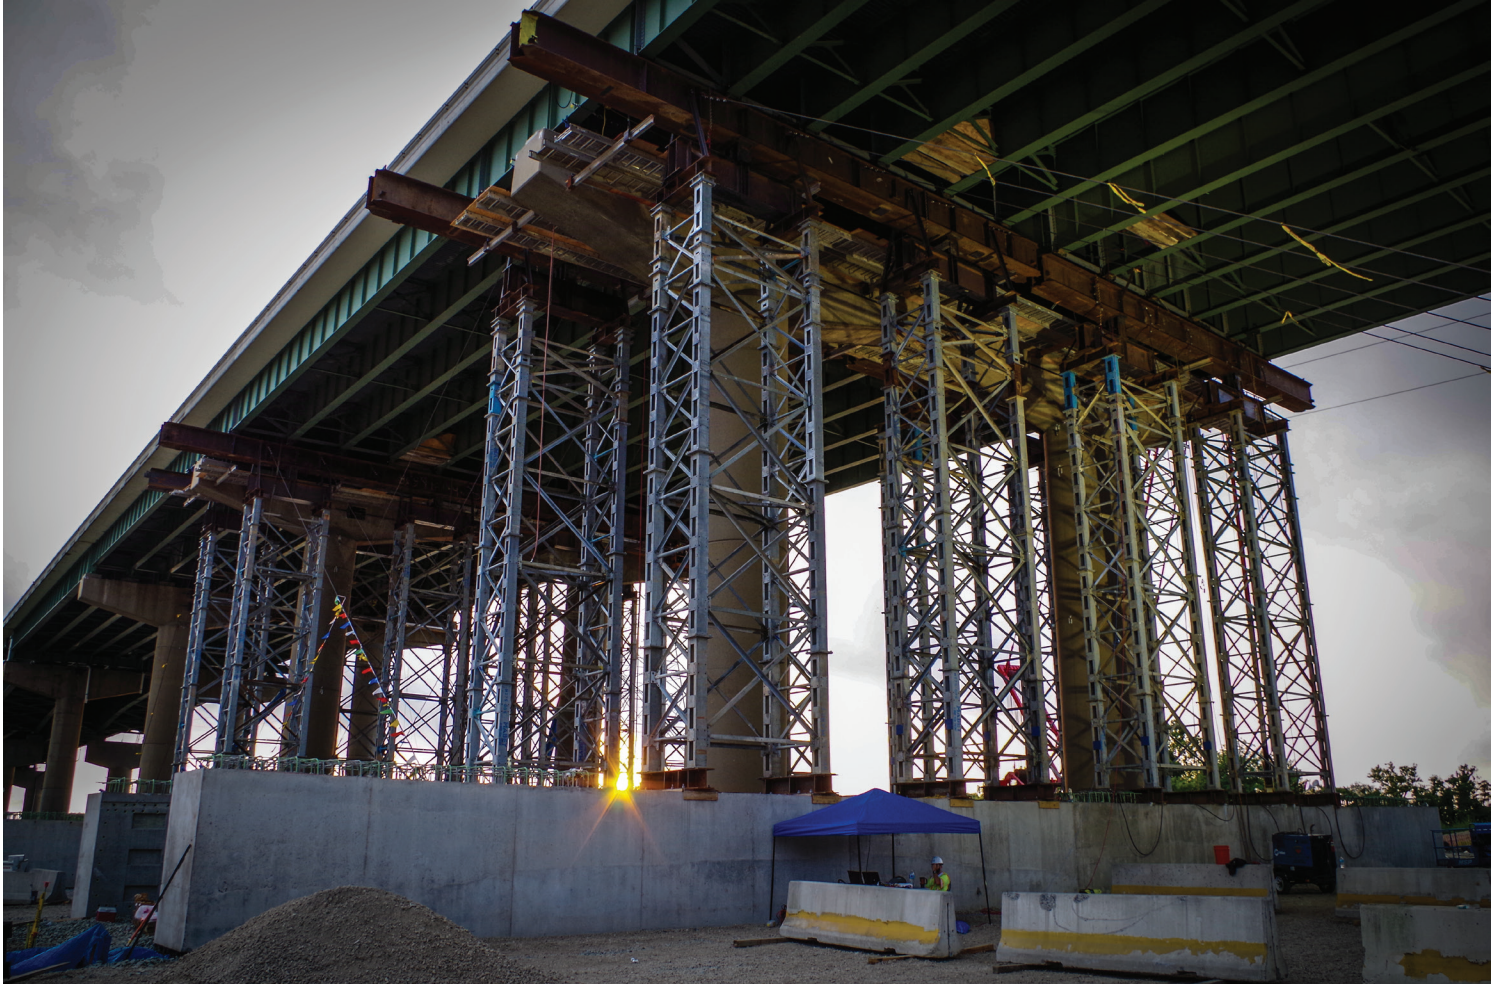
Within 40 minutes of being alerted to the problem by DelDOT, IIS engineers were on site to assess the condition of the bridge. Transverse rotations up to 4 percent from their original position were observed in Piers 11 through 14, causing the median barriers to be vertically out of alignment by as much as 17 inches, which was

visible from the roadway. It was later determined that this rotation was a result of a large earth embankment (estimated at 50,000 tons) placed immediately adjacent to the structure, causing compression of the underlying soft soils and lateral pressure on the bridge foundations.

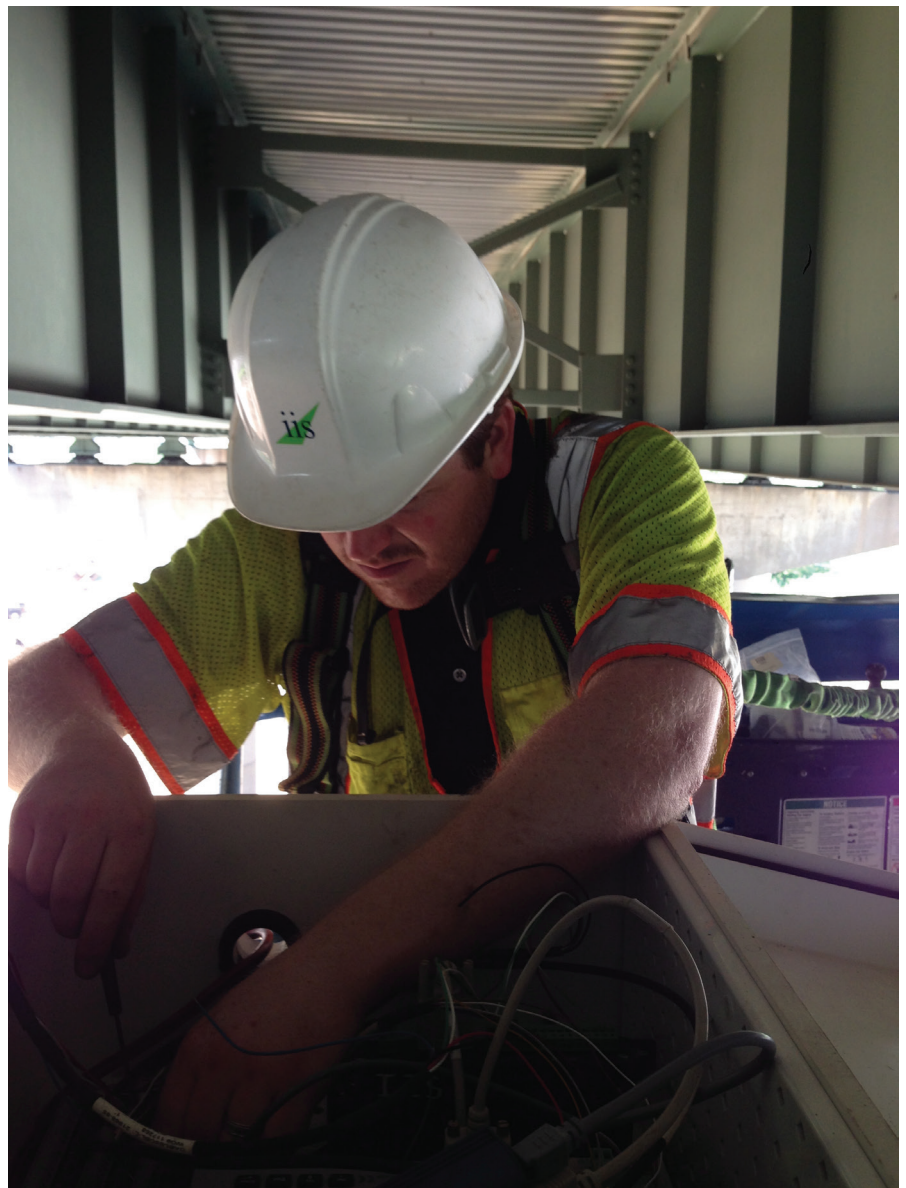
Following completion of the permanent repairs, IIS installed a long-term monitoring system consisting of 48 tiltmeters. Five remote Campbell Scientific AVW206-AM16/32B data-acquisition units read and provide power to the tiltmeters. The remote units are powered by a Campbell Scientific SP10/BP12 solar panel and battery combination. Every 15 minutes, an RF401 spread-spectrum radio transmits data to a CR3000 base station, and then two Sierra Wireless cellular modems transmit the data to DelDOT and IIS.
