Wyoming: Landslide Warning

Campbell dataloggers at heart of landslide warning system

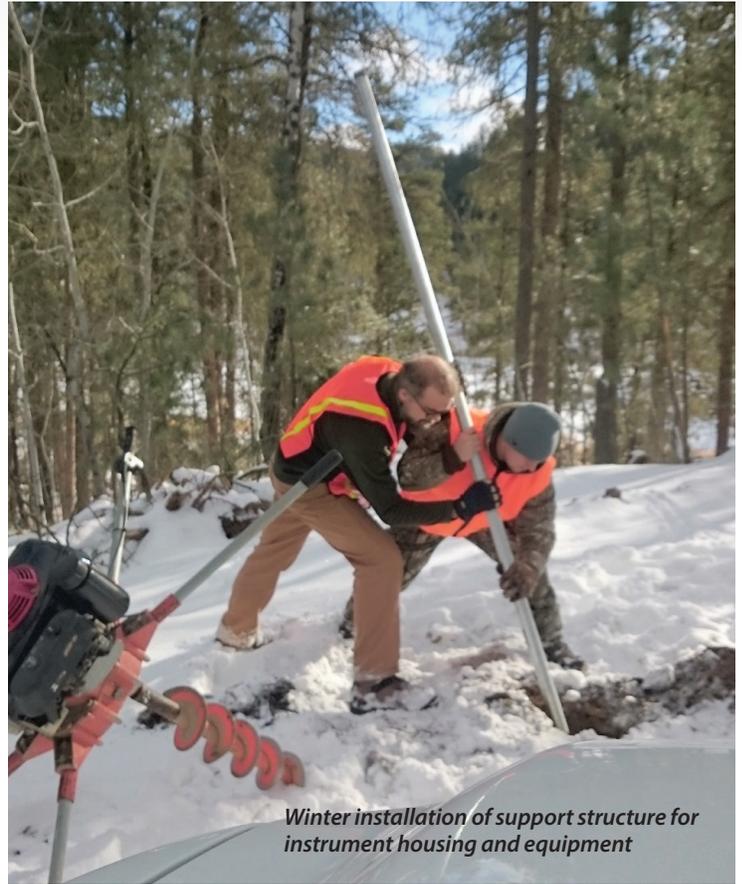
Winter installation of support structure for instrument housing and equipment

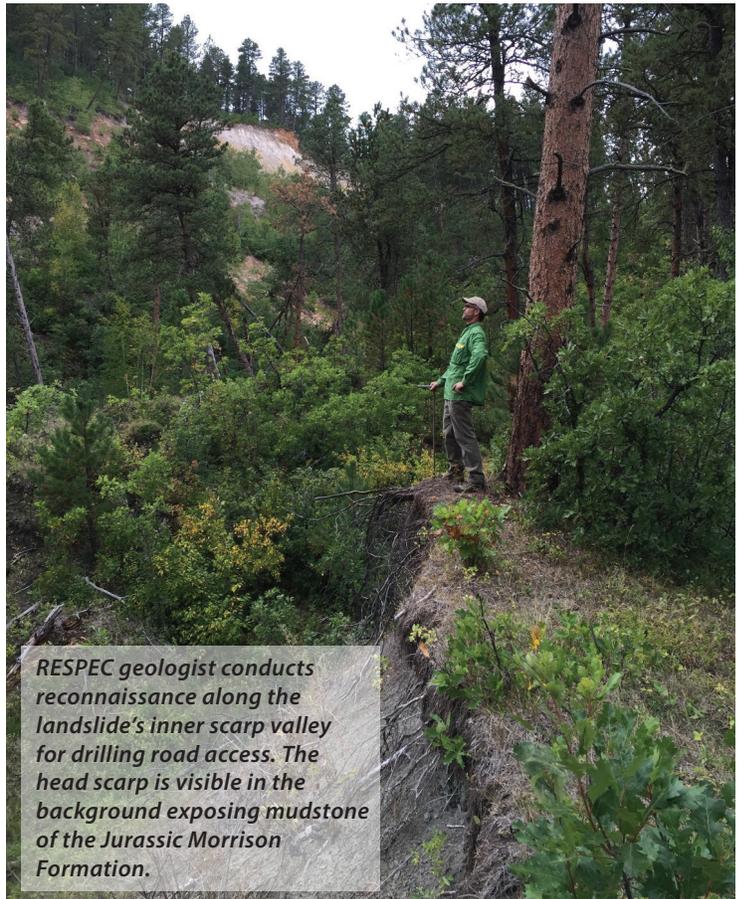
RESPEC geologist conducts reconnaissance along the landslide's inner scarp valley for drilling road access. The head scarp is visible in the background exposing mudstone of the Jurassic Morrison Formation.
