City of Edmonton: Vibration Complaint Resolution

CSC camera helps identify sources of vibration complaints

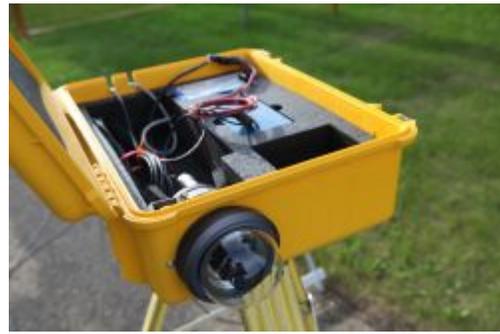
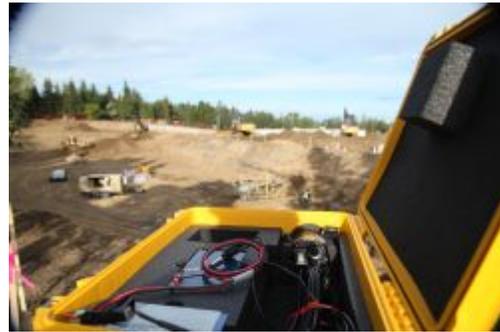
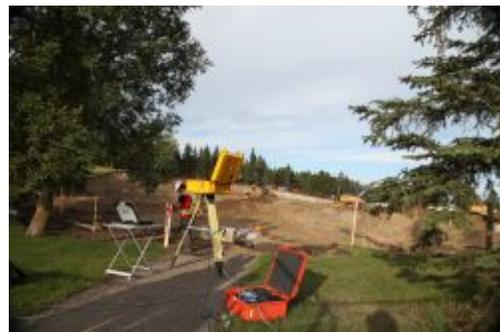
A typical ground vibration test would see the 2 InstanTel sensors placed in the test area; one near the road or house (depending on the complaint), and the other near the property line. The readings from each sensor are compared and if their readings are above a pre-established ‘acceptable’ limit, an alarm triggers the CC5MPXFE to capture an image.

The CC5MPXFE is a high-resolution digital camera that’s fitted with a fisheye lens, allowing it to capture hemispherical images. This camera has the ability to be triggered based on an external signal, such as the alarm the InstanTel outputs, making it a perfect fit to work in conjunction with the InstanTel Seismograph. Plus, it’s housed within a rugged environmental case that can withstand the harshest of conditions.
