## UTBASE Corrosion Testing

### Determining Optimal Materials

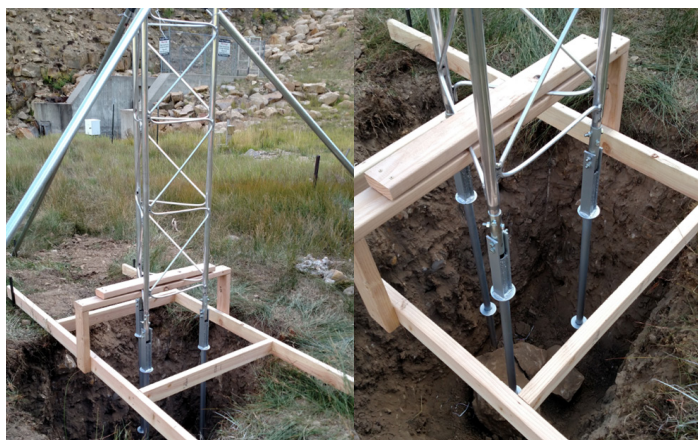
Figure 1: B18 and Tower Installation

For many years, the B18 has been our most common base for the 6 and 10 m (20 and 30 ft) towers. This base consists of tubes used as extensions to the tower legs that are embedded in a concrete pad (Figure 1).

Prior to placing concrete, the B18 tubes must be attached to the lowest tower section, and the tower trued. Adjustments to level the tower are not possible after the concrete has cured.

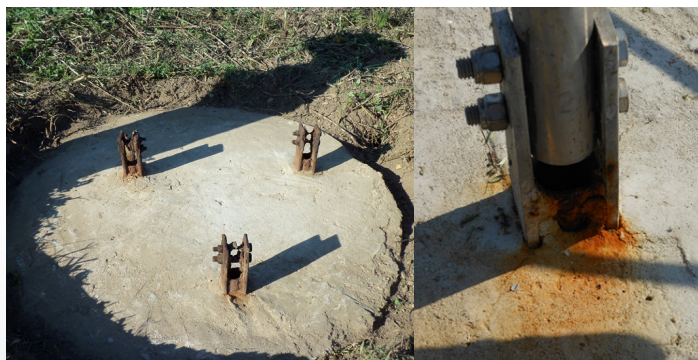
Figure 2: Corrosion in a coastal environment

While galvanic corrosion due to the transition from the steel B18 to the aluminum tower has not been an issue, the B18 is susceptible to corrosion, particularly in the presence of salts such as in coastal environments or roadway installations (Figure 2). Once corrosion structurally compromised the B18, the user had to take down the tower, pour a new concrete pad, and reinstall the B18 base and tower.
