# **Antarctica: Historical Hut Preservation**

# Campbell Scientific Australia provides vital environmental monitoring to a nation's past

Monitoring environmental parameters in support of the effort to preserve Mawson's Hut

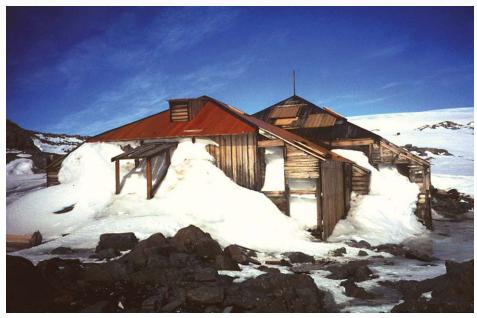
Mawson's Hut, an Australian symbol of the Heroic Era of Antarctic Exploration, sits on Cape Denison, Commonwealth Bay, a site recognized as the windiest place on earth at sea level. (Photo courtesy of Steve Martin, State Library, NSW)

Cape Denison, the site of Mawson's Hut, is recognized as the windiest place on earth at sea level. On average, the daily maximum wind speed is 44 mph, and the temperature ranges from 0°C to -20°C. The site consists of four buildings: the Main Hut, Magnetograph House, Transit Hut and Absolute Magnetic Hut. The Main Hut and Magnetograph House have weathered their 100 years reasonably well. The Transit Hut and Absolute Magnetic Hut have been stabilized for conservation as "standing ruins."
