## Canada: Structural Health Monitoring of an Overpass

*Providing real-time, high-quality data to help extend the lifespan of an aging overpass*

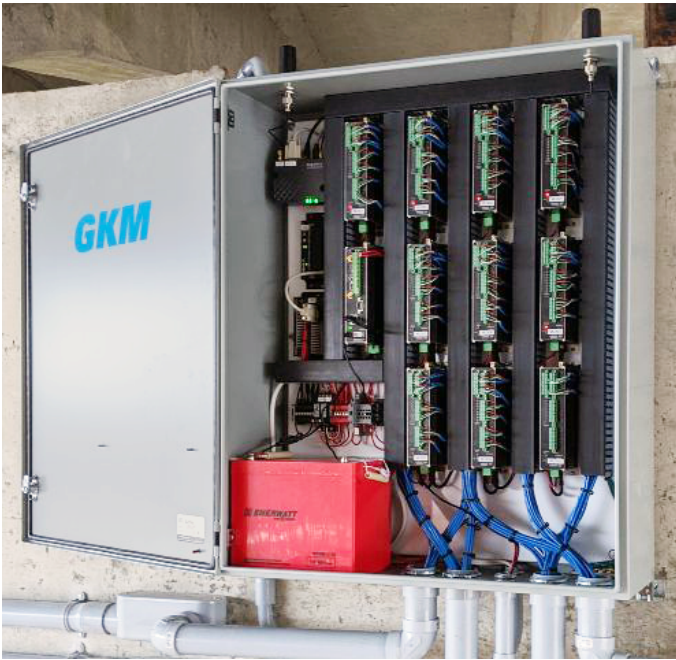
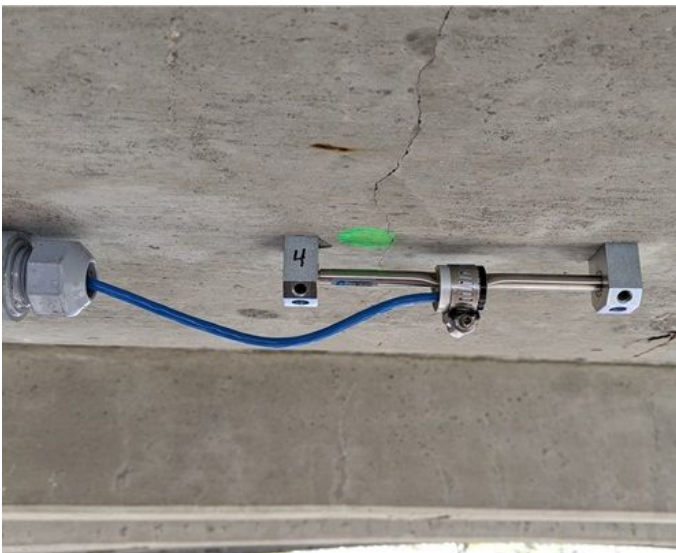
*Vibrating-wire strain gauge installation to a girder's bottom flange*

GKM installed 72 vibrating wire strain gauges (Geokon model 4000) on the girders of the structure. While foil strain gauges are a typical choice for high-speed data acquisition, their output tends to drift over time. The enhanced stability of vibrating wire strain gauges makes them a better choice for long-term monitoring despite their lower bandwidth. Strain gauges are often attached to a structure using an epoxy glue. However, this method is not compatible with a cold-weather installation, and degradation of the glue-concrete interface renders comparison of measurements unreliable after a few years. The preferred method for long-term monitoring is to use drop-in concrete anchors, but standard anchors are long with respect to the thickness of the girder's web. Therefore, the unique conditions of this structure required the development of custom anchors with the collaboration of Geokon. The strain gauges were installed in rosette patterns to measure both strain and shear.
