## Colombia: Fighting Fungus on Roses

*Campbell gear used to study conditions in rose greenhouses*

Study of growing conditions of roses, gathering data for battling fungus growth

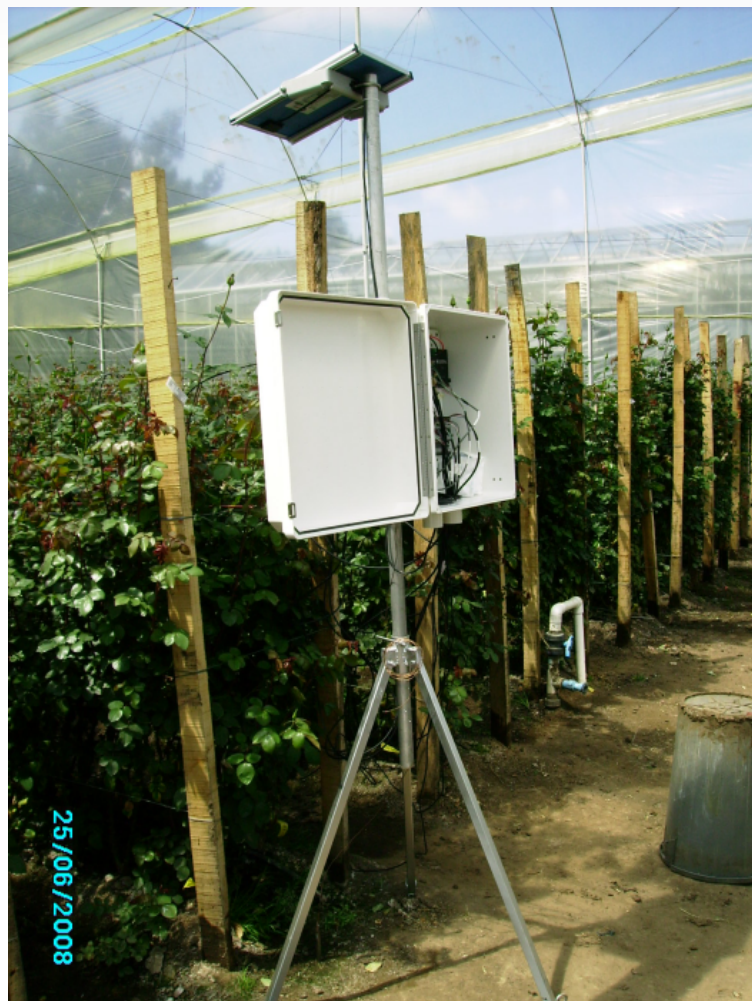
*(Photo courtesy of Francisco Gonzalez, Durespo)*

To set up the study, researchers built two measurement stations to monitor the conditions in greenhouses where roses were growing. The stations, powered by solar panels, included several Decagon LWS Leaf Wetness Sensors and Apogee SI-111 Infrared Radiometers positioned at a variety of locations among the plants. These sensors were connected to Campbell CR1000 dataloggers via our AM16/32 multiplexers. The instruments, power supplies, and enclosures all came from Campbell Scientific and were configured by Durespo, Campbell's local sales representative in Colombia.

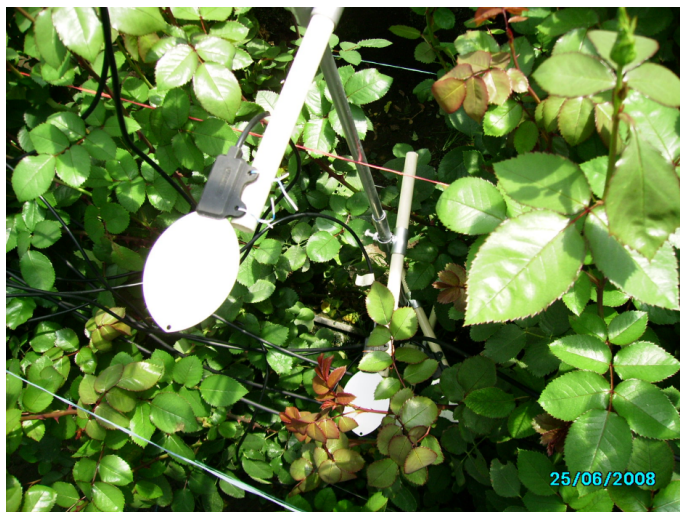
(Photo courtesy of Francisco Gonzalez, Durespo)
