Delaware: Urgent Action on Bridge

Campbell gear used in emergency inspection of I-495 bridge over Christina River

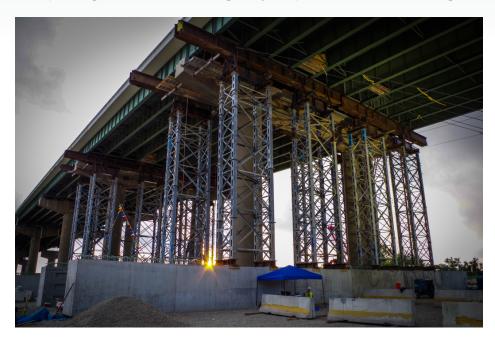
Within 40 minutes of being alerted to the problem by DelDOT, IIS engineers were on site to assess the condition of the bridge. Transverse rotations up to 4 percent from their original position were observed in Piers 11 through 14, causing the median barriers to be vertically out of alignment by as much as 17 inches, which was visible from the roadway. It was later determined that this rotation was a result of a large earth embankment (estimated at 50,000 tons) placed immediately adjacent to the structure, causing compression of the underlying soft soils and lateral pressure on the bridge foundations.

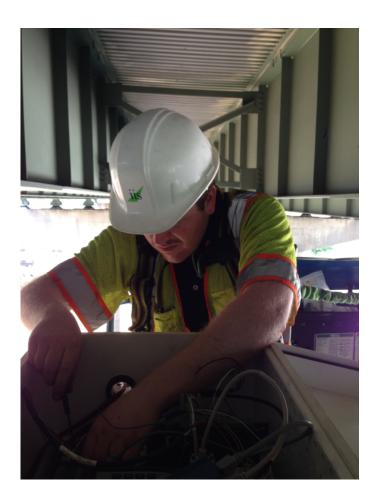
Following completion of the permanent repairs, IIS installed a long-term monitoring system consisting of 48 tiltmeters. Five remote Campbell Scientific AVW206-AM16/32B dataacquisition units read and provide power to the tiltmeters. The remote units are powered by a Campbell Scientific SP10/BP12 solar panel and battery combination. Every 15 minutes, an RF401 spread-spectrum radio transmits data to a CR3000 base station, and then two Sierra Wireless cellular modems transmit the data to DelDOT and IIS.
