Florida: Crack Monitoring at a Historic Site

Campbell Scientific equipment helps to preserve and restore a historic monument

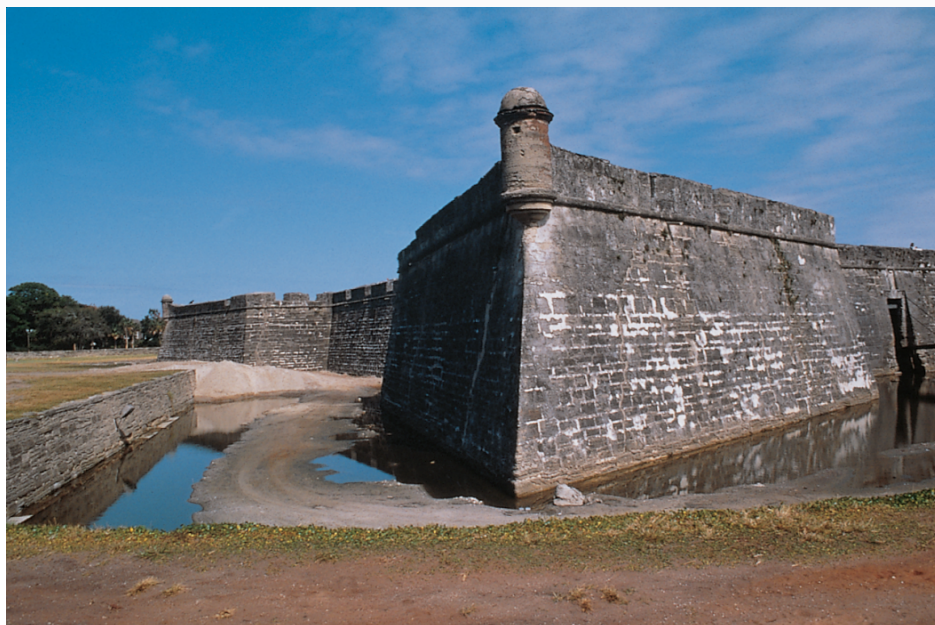
Castillo de San Marcos National Monument, St. Augustine, Florida. Taken in 1995, this view looks across the moat toward the southwest bastion, where several major cracks are visible.

The fort's bastions are earthen-filled, masonry ramparts, constructed on shallow foundations. Two of the four bastions have evidenced cracks since the early 1800s. The fort's foundations ought to be structurally sound according to an extensive investigation of both the foundations and the soil bearing capacity. An emerging theory postulates that the wall construction is near its structural limit in retaining the earth fill. Rainwater infiltration may increase the internal load on the walls, causing the structure to move. A design team was formed to investigate this theory. Headed by architects Grieves Worrall Wright & O'Hatnick, the team proposed that the park monitor:

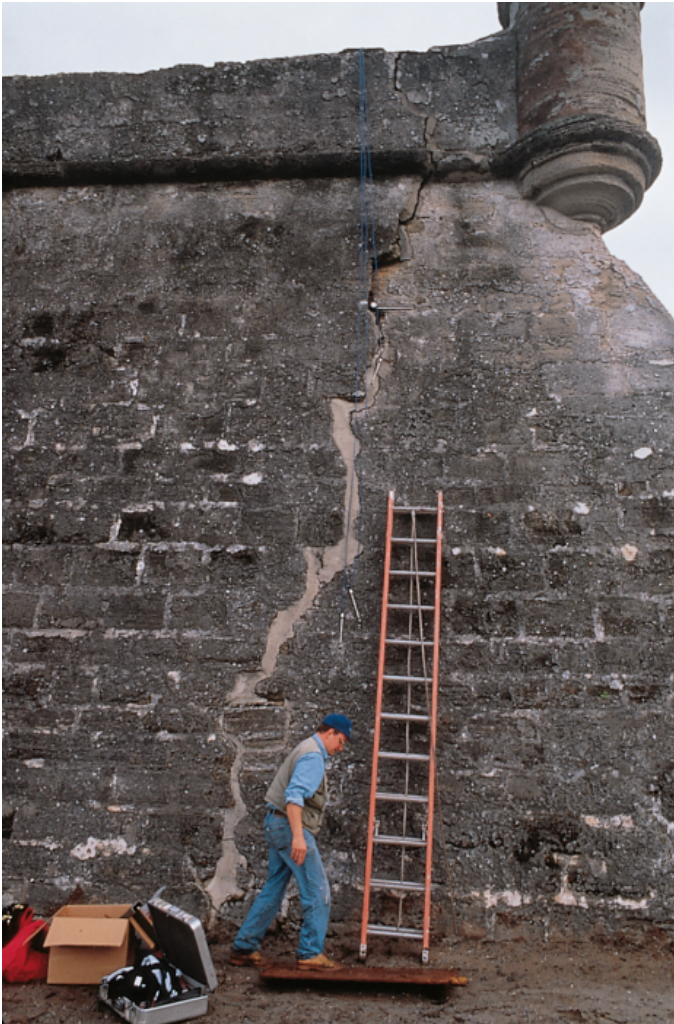
Sensors are installed across a crack in the southwest bastion.

Monitoring equipment was assembled from several vendors. Campbell Scientific provided the datalogger, multiplexers, weather stations, and soil moisture probes. The equipment was integrated with crack and tilt sensors manufactured and installed by Geokon (Lebanon, NH). AMJ Equipment (Lakeland, FL) and PSI Engineering (Jacksonville, FL) provided technical and installation assistance. To reduce the installation's aesthetic impact on the park, cables were concealed in custom conduit with the help of the park's maintenance staff.

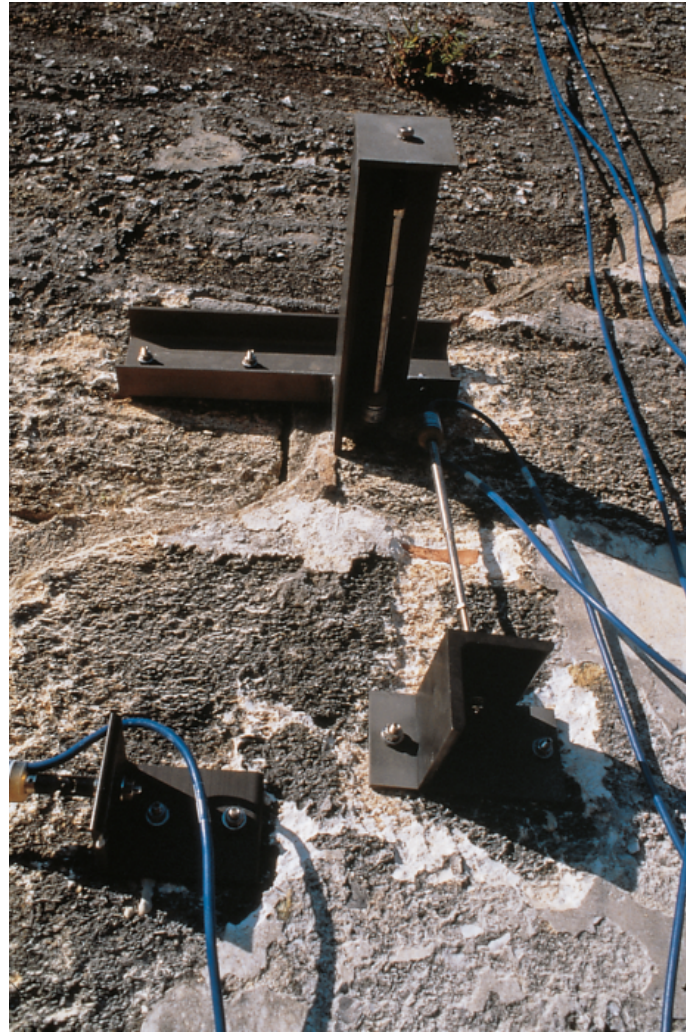
Sensors straddle cracks to directly measure displacement in each of three axes.
