## Post-fire restoration work

A spectacular fire destroyed three-quarters of the roof of the Basilica of Saint Donatian and Saint Rogatian in Nantes in June of 2015. Restoration work began in January of 2016 with securing the construction site. The architect requested the installation of 26 wire extensometers (or distance sensors) above the vaults of the choir and transept. With these electronic sensors in place, it was possible to monitor the settling of the vaults during the installation of the immense temporary roof structure and the shoring of the vaults inside the building.

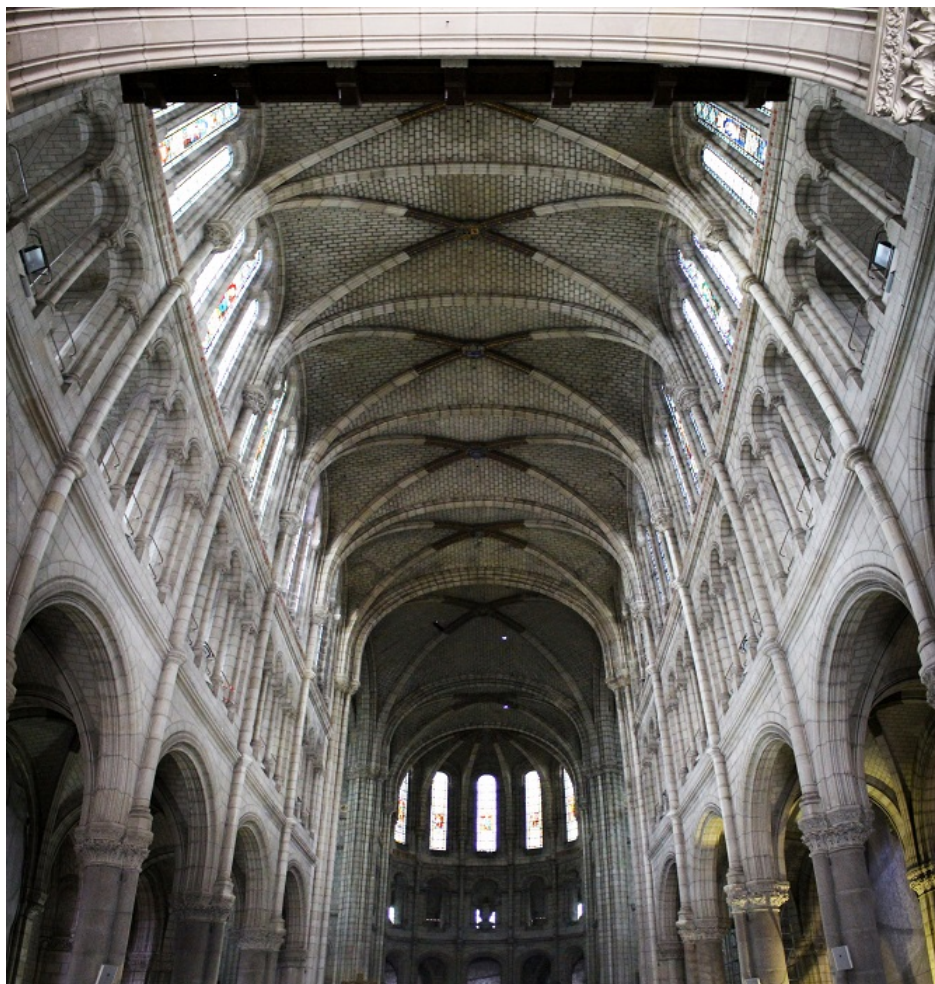
Two CR1000 and CR6 dataloggers were used to record and analyze the data from the sensors. Each data value had to be analyzed every second to trigger an alarm above the vaults and another alarm inside the basilica in case of significant settling. Moreover, the alarms would notify the relevant personnel via SMS that an identifiable sensor had exceeded its alert threshold.
