## Campbell data loggers at heart of landslide warning system

Landslide warning system

Northeastern Wyoming, USA

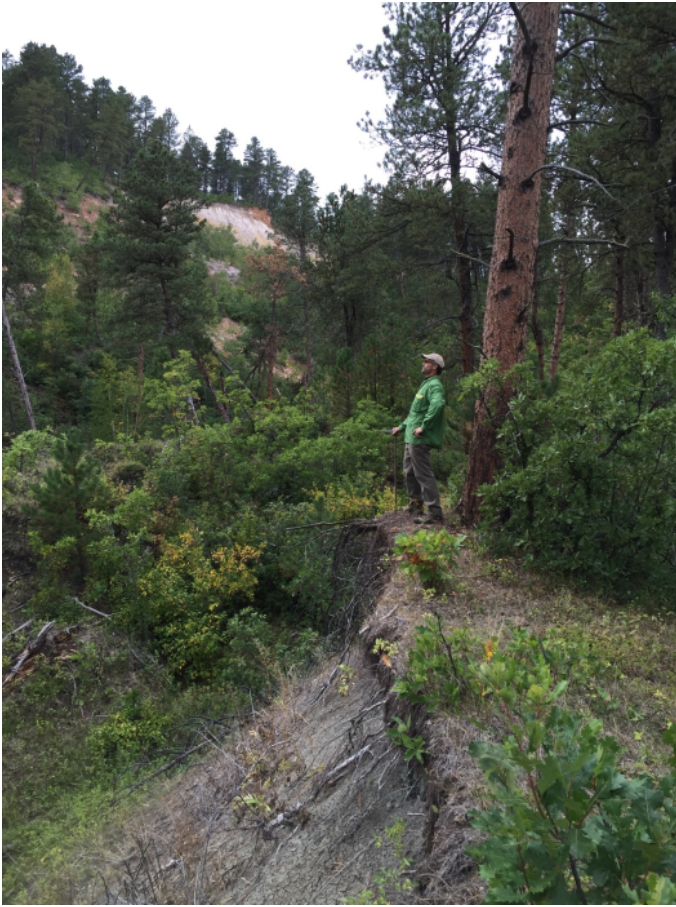
*RESPEC geologist conducts reconnaissance along the landslide's inner scarp valley for drilling road access. The head scarp is visible in the background exposing mudstone of the Jurassic Morrison Formation.*

In 1997, after several years of record rainfall, a large, 27-acre rotational landslide occurred at night in mudstone strata of the Jurassic Sundance and Redwater formations due to soil saturation. A near-vertical, 15-meter head scarp was formed, along with a large muddy toe from the extrusion of fluidized clay that displaced the western shoreline of the 31-acre lake. A 19-unit campground and popular hiking trail were evacuated and closed. The lake's dam was threatened with failure from overtopping, which could lead to downstream flooding and possible loss of life. The landslide remains active today, with numerous occurrences of audible tree cracks, visible rock fall, tension cracks, and a fluctuating shoreline.
