Innovative Sensor Design for Prevention of Bio-fouling

Boyd Bringhurst

Jeff Adams
Campbell Scientific, Inc.
Logan, Utah, USA
boyd@campbellsci.com

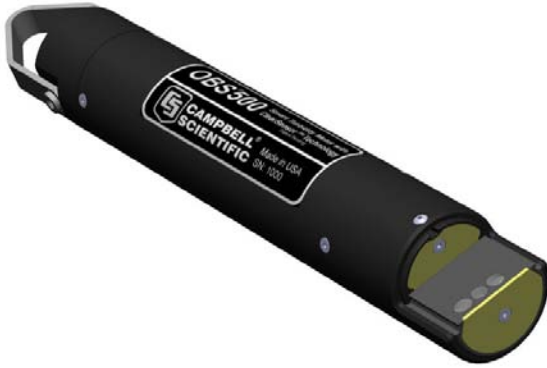
Figure 1. Prototype sensor design

A prototype optical turbidity sensor was chosen to test a new bio-resistive design as this measurement is particularly susceptible to bio-fouling. Based on the test panels and a search of the literature, a prototype was designed that incorporates new shutter and wiper designs, biocides, and removable sleeves.

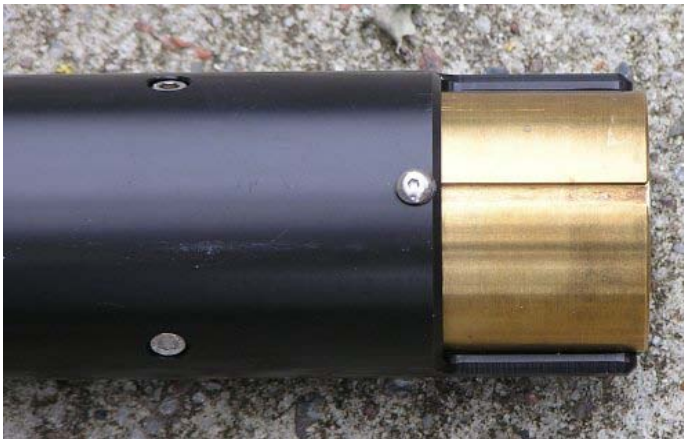
The shutter shown in Fig. 2 reduces biological activity by limiting biological organisms and sunlight from reaching critical sensors surfaces [1]. The shutter resting upon the sensor surface leaves no space for growth.

Figure 2. Shutter closed over sensor optics

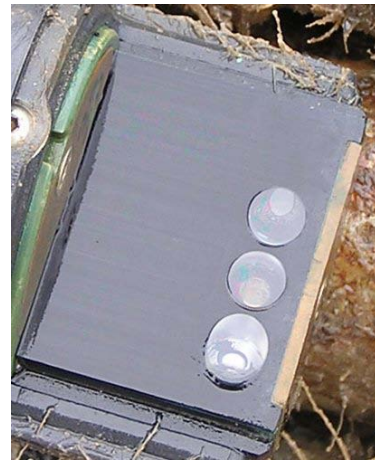
The wiper shown in Fig. 3 is able to displace biological or other material that starts to form under a shutter [2].

Figure 3. Wiper displaces fouling as it pushes across optics

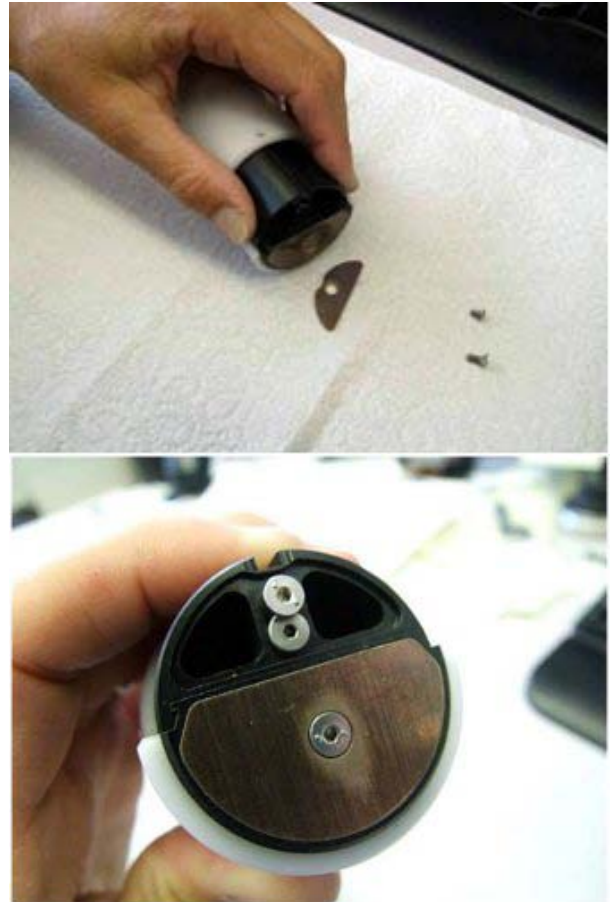
A chemical biocide slowly leaching over the sensor surface prevents attachment of organisms [1]. Unabated, these organisms lead to more biological growth on the sensor. The refillable chamber shown in Fig. 4 allows for a biocide such as bromide, cayenne pepper, or copper braid to be placed in the prototype.

Figure 4. Refillable biocide chamber

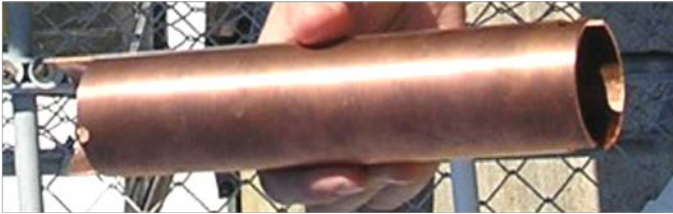
Materials such as copper and "coin" silver are known biocides [4][5]. Use of these materials in the sensor body will slow biological growth.

Figure 5. Copper sleeve to prevent fouling of sensor body

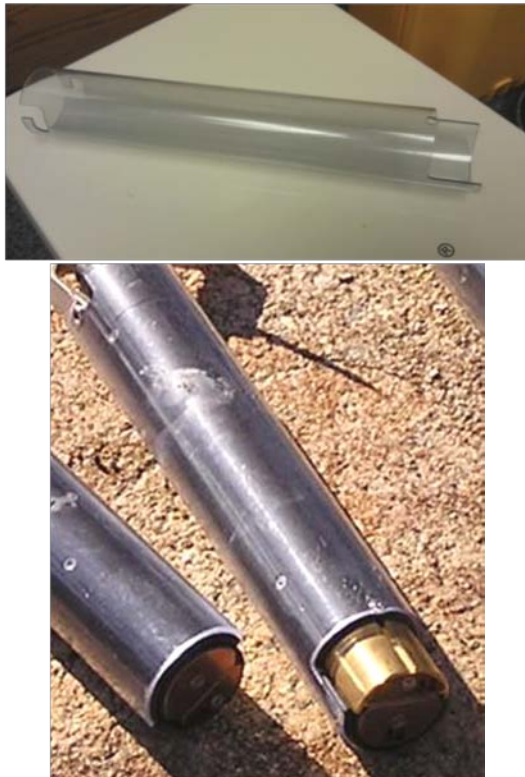
Shown in Fig. 6, easily removable disposable sleeves allow for quick cleaning of the sensor body at calibration checks. Beyond keeping the sensor optics clean, as the sensor body becomes overgrown with biological activity, the sensor is negatively influenced.

Figure 6. Plastic sleeve provides easy cleaning

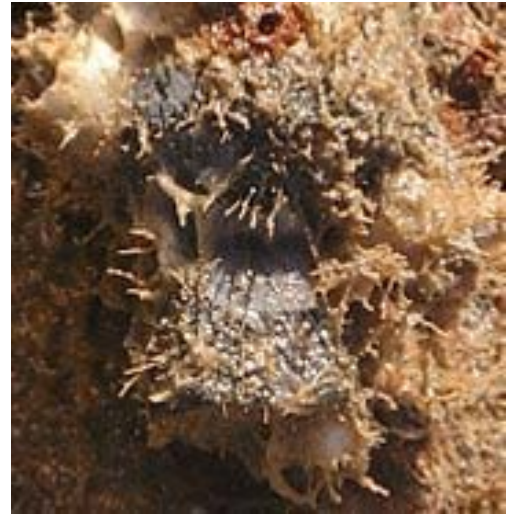
Figure 7. Baseline sensor, day 36 before cleaning

A commercially established back scatter sensor with no anti-fouling design was deployed alongside the prototype to provide a baseline comparison. The prototype received no maintenance. The baseline sensor was cleaned at regular intervals to provide data showing that cleaned baseline sensors come back into agreement with the prototype. Figs. 7 and 8 show the before and after effects of sensor cleaning.

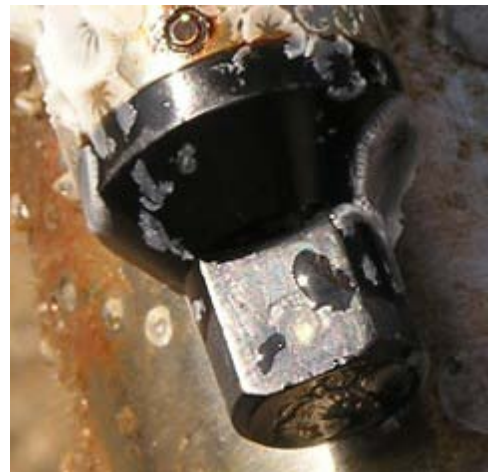
Figure 8. Baseline sensor, day 36 after manual cleaning

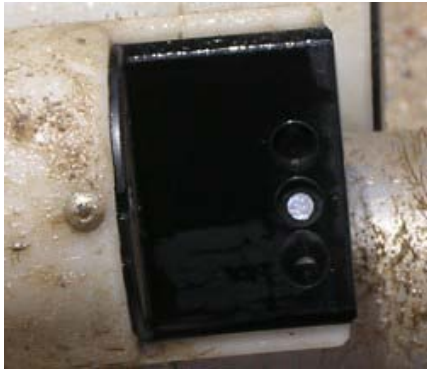
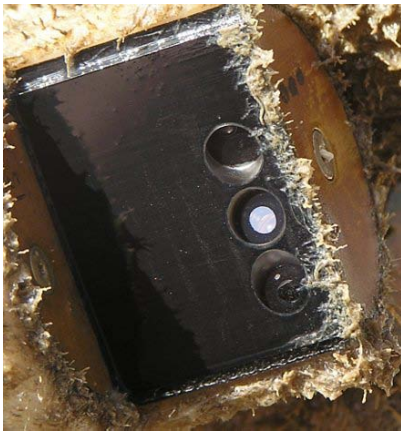
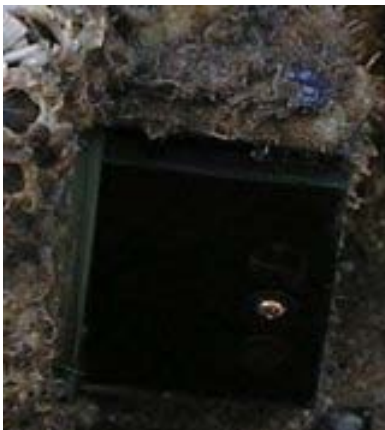
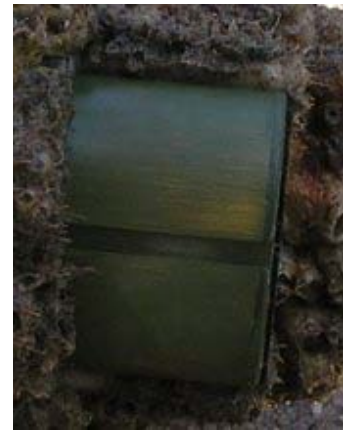
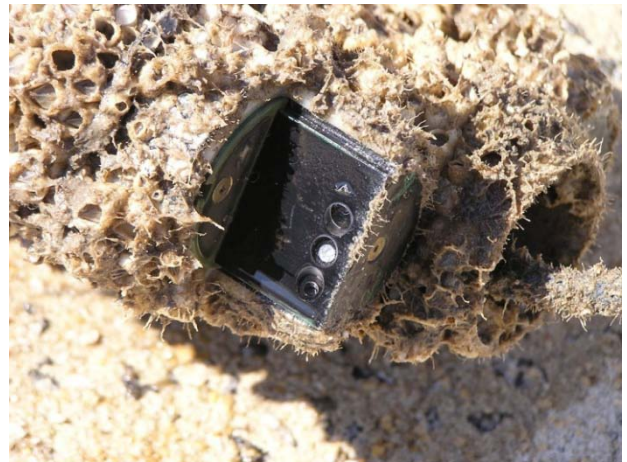
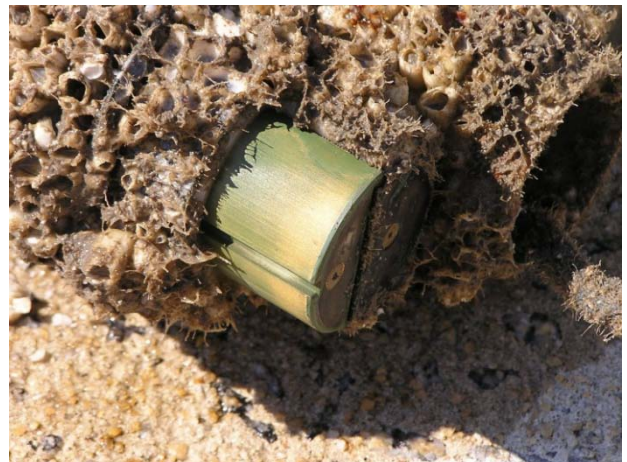
Skidaway Island experiences a semidiurnal tide. Figs. 10 through Fig. 15 show the progression of biological growth on the prototype, but the sensing element remains free of fouling.

Figure 10. Day 13, shutter open (GA)

Figure 11. Day 36, shutter open (GA)

Figure 12. Day 103, shutter open (GA)

Figure 13. Day 103, shutter closed (GA)

Figure 14. Day 119, shutter open (GA)

Figure 15. Day 119, shutter closed (GA)

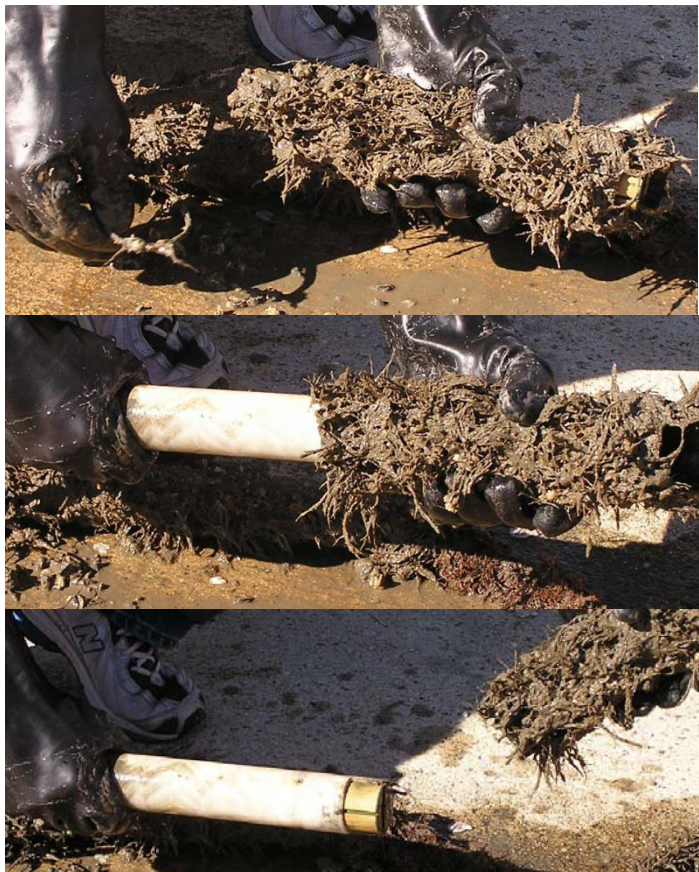
Figure 17. Process of removing a disposable plastic sleeve

Fig. 17 is a series of photos illustrating quick and easy removal of a disposable plastic sleeve at a Savannah, GA site. Where water quality measurements are made in open waters, the existence of an active biological community near the sensor has been observed to degrade measurements, even if sensor windows are clean. Keeping clean sleeves on the sensor at some regular maintenance interval will likely help measurements be more representative of the natural environment.

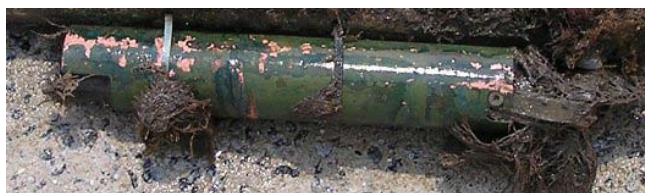
Figure 19. Copper sleeve after 137 days at Skidaway Georgia site

Fig. 18 shows a copper sleeve. Fig. 19 shows a copper sleeve 137 days after deployment. Fig. 20 shows significantly more biological growth on a plastic sleeve after 137 days.

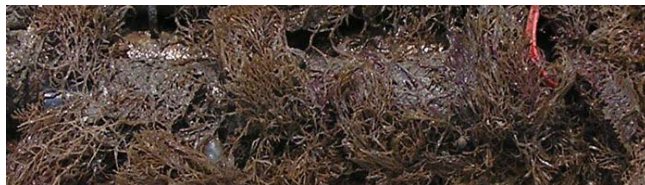
Figure 20. Plastic sleeve after 137 days at Skidaway

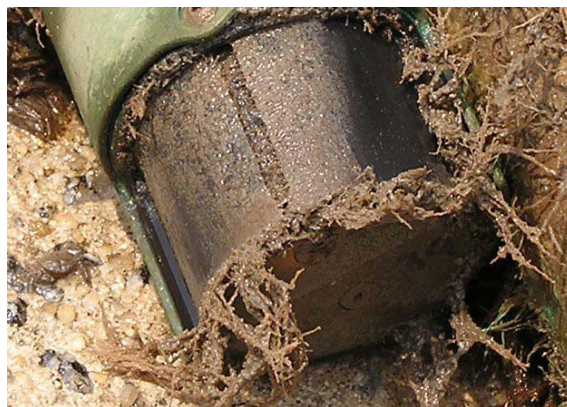
Figure 21. Delrin after 137 days at Skidaway

The Delrin shutter/wiper has growth on the tip (Fig. 21), whereas the brass remains relatively clean (Fig. 22). The growth on the Delrin shutter hung in the view of the back

scatter optics resulting in measurement error. A sensor with a brass shutter performed significantly better.

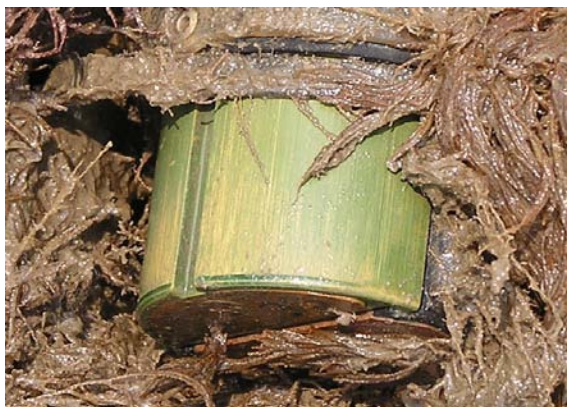
Figure 22. Brass after 137 days at Skidaway
