# APPLICATION NOTE

## **GPS16X-HVS Firmware** **Update Procedure**

4/19

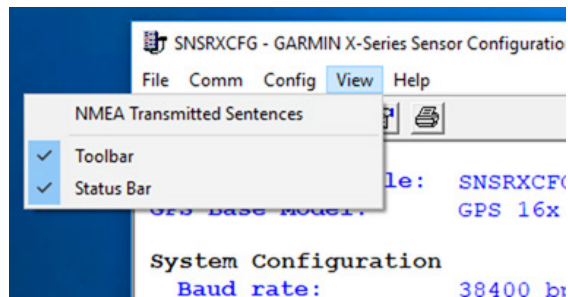
If the \$GPRMC date shows something other than the current date (following example shows 220899, which is the 22nd day of August 1999), it did not roll over, and you need to update the firmware by following the remaining steps in the procedure:

9. If you need to update the firmware, go to **Config > Update Software**.
